Technical Service Bulletin

Battery dead or low after returning to the vehicle

91 07 13 March 5, 2007, 2014127/1

Model(s)	Year	VIN Range	Vehicle-Specific Equipment
A6	2007	Up to 4F 7N073265	Not Applicable
A8	2007	Up to 4E 7N010103	
Audi Q7	2007	Up to 4L 7D063347

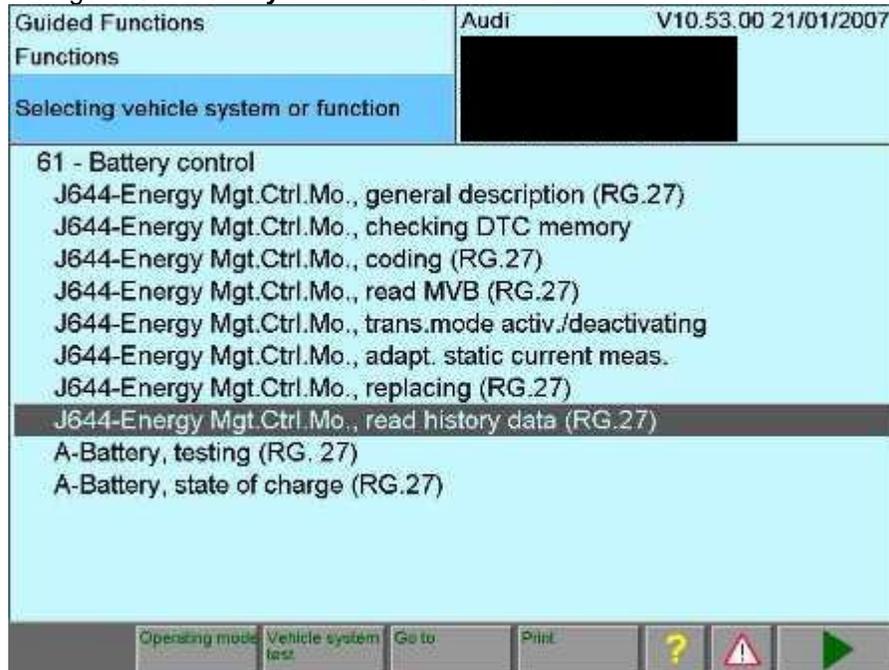
Then go to **61 - Battery control** in Guided Functions and select the following menu:

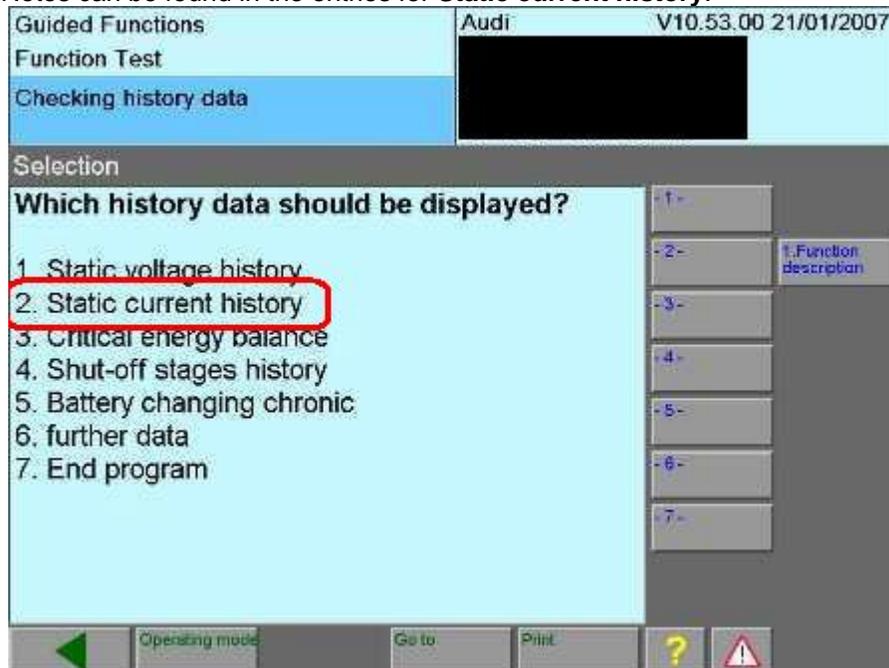
Notes can be found in the entries for **Static current history**:

An increased quiescent current was measured over a total period of 203 hours.

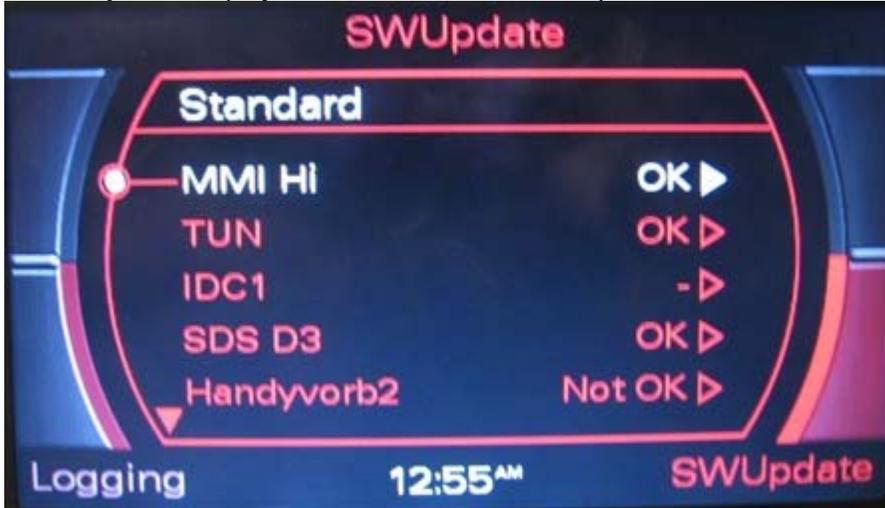
Tip: The displayed status **Not OK** and - is update related and not a fault. Please ignore and proceed.

11. After initialization of the updated components, the following screen (or a similar one) appears.
