Removing and installing display unit for front information display and operating unit control unit -J685-

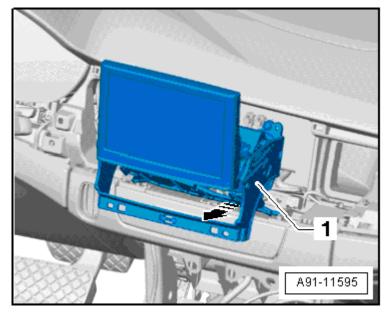
- Extend display unit for front information display and operating unit control unit -J685-.
- Carefully pull display mounting -1- out of dash panel -arrow- until electrical connectors at display unit for front information display and operating unit control unit -J685- can be reached.
- Release and unplug electrical connector for display mounting.
- Pull display mounting completely out of dash panel.

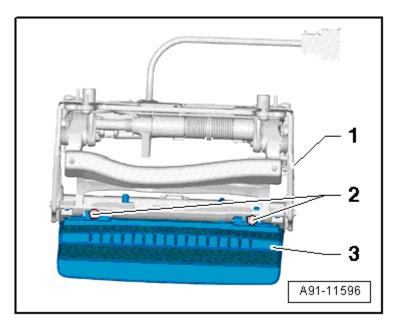
The display unit for front information display and operating unit control unit - J685- is attached to the display mounting with two securing bolts.

Remove bolts -2- and detach display unit for front information display and operating unit control unit -J685--3from display mounting -1-.
