Fixing the central locking vacuum pump of an Audi D2 A8/S8 (when due to broken rubber boot)

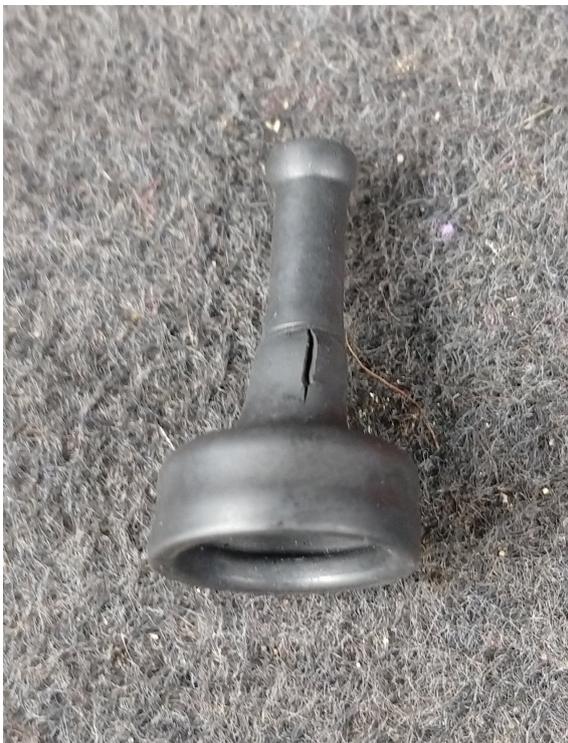
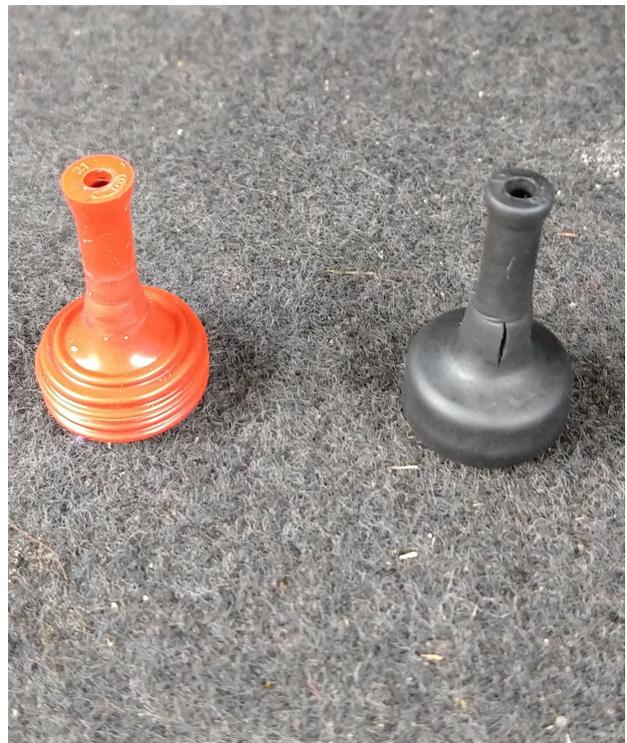
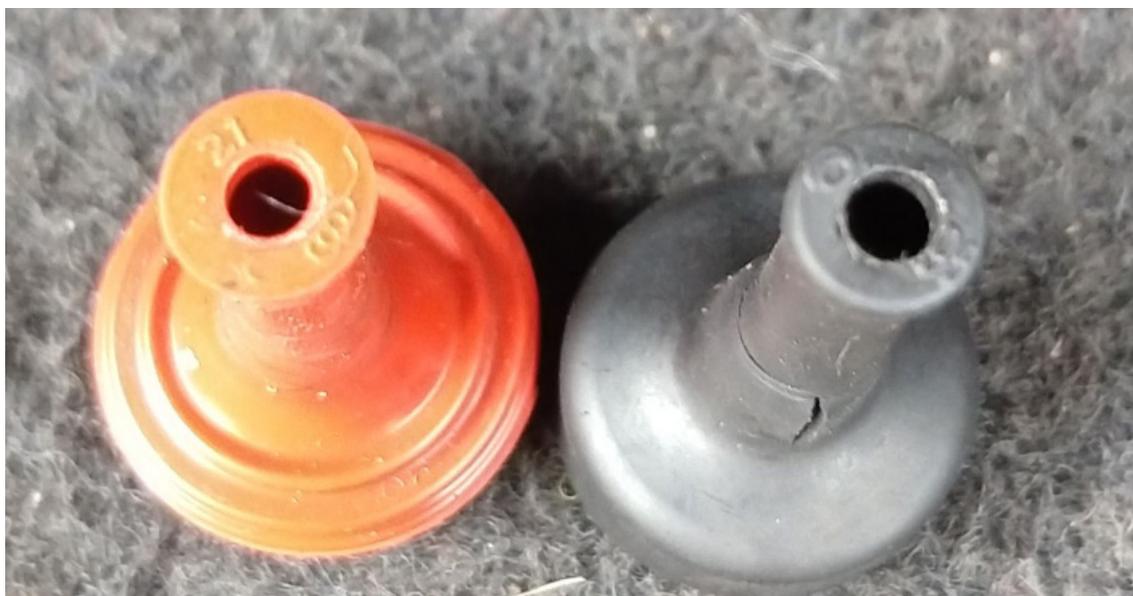
Every Audi that I have ever owned except my C4 100q has had this rubber boot split. My D2 S8 came into my ownership with it so. I could tell from the first time that I locked the vehicle that there was a leak in the central locking system because I could hear the familiar noise of the central locking pump groaning somewhere in the rear of the vehicle. It persists for several seconds and eventually gives up. Normally, if there was no leak you would only hear this groan for a second or so.

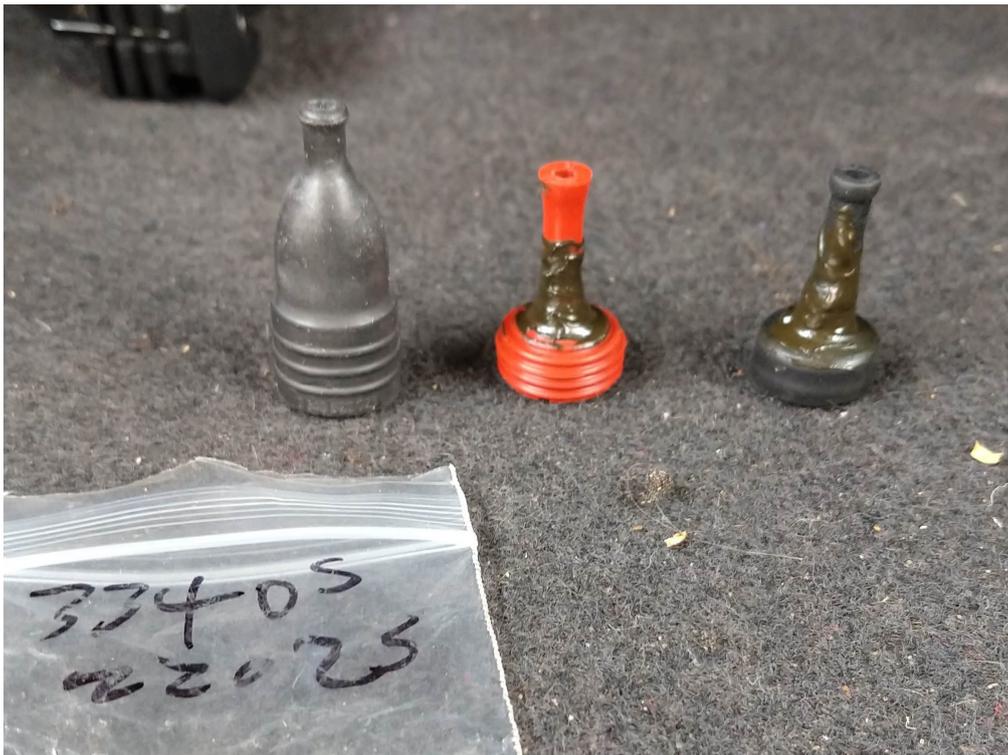
Here is a picture of the boot (on the left) that i bought as a replacement a year or so ago as a possible fix. It also split within a year of use. The orange one is out of my C4 100q and is still going strong.

I have painted it with gasket sealant in the hope that it will last longer and installed it into my S8 to replace the split boot. No more extended groaning....and presumably extra wear on the central locking pump.

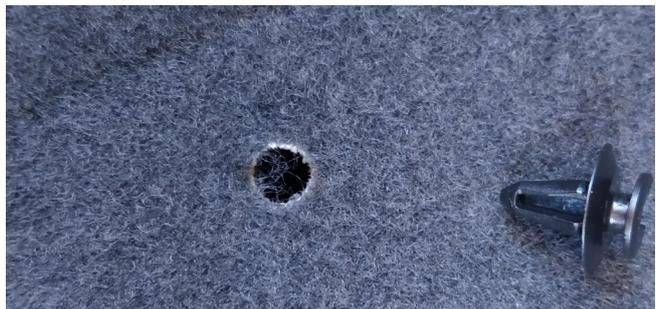
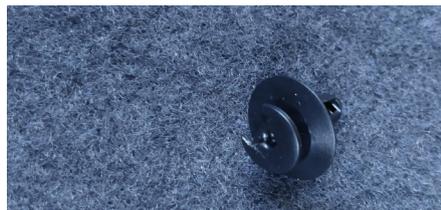
These trim clips are located in the middle of the trim. Trim can now be removed from boot lid.

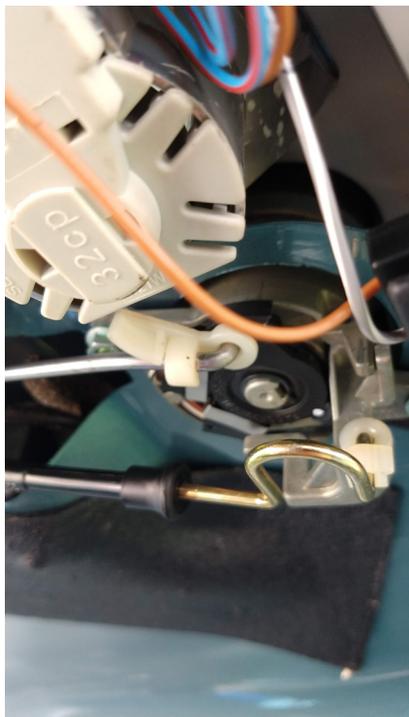
The silver rod has a whitish retaining clip securing it into the rear of the boot lid lock mechanism. Pull this clip away from the rod and you can then withdraw the rod downward and away from the mechanism. The other end of this rod is attached to the vacuum pump lock actuator.

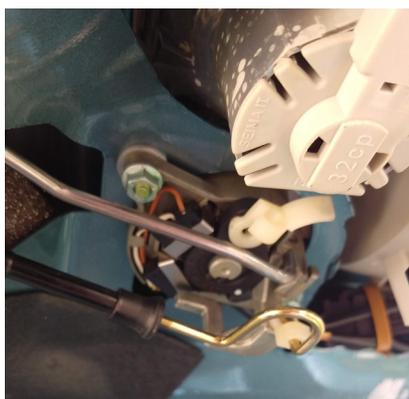
In my case the rod had somehow already come out of the mechanism without my intervention...! If you have the same case, there is a hole in the black part of the mechanism where it should be fitted as shown in the picture above.

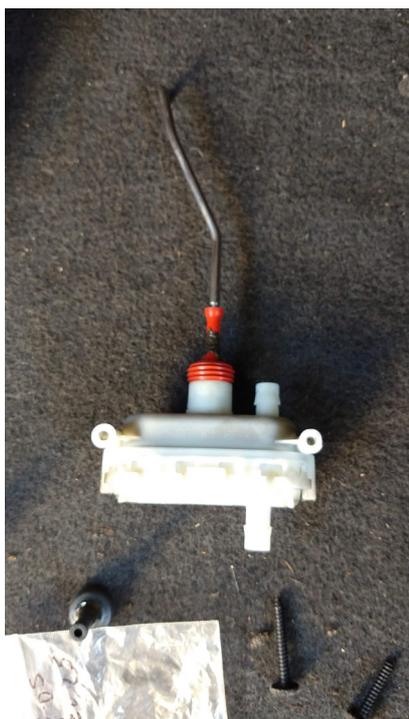
This is the vacuum pump lock actuator removed from the boot lid. It is held in by the two screws in the picture.

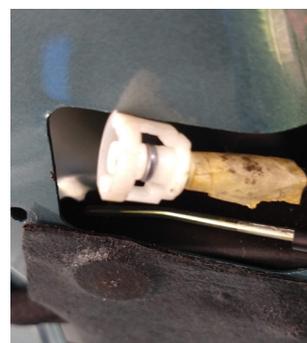
You will also have to remove this hose from the actuator before you remove it. Squeeze the sides of the white retaining thing and prise gently to release.

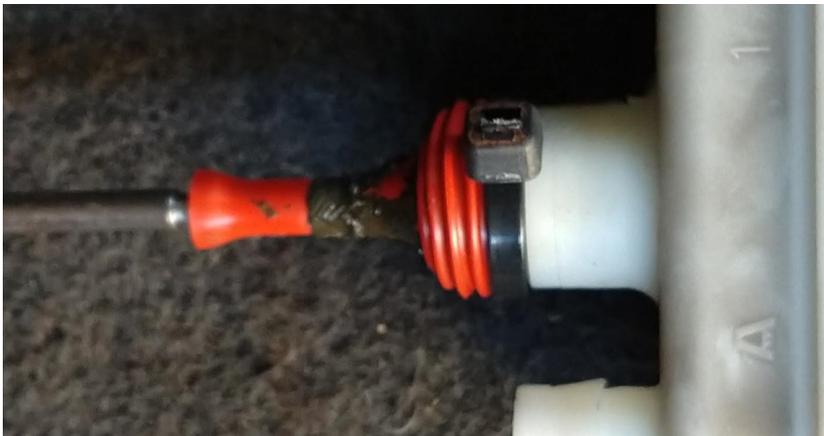
Notice the rebate on the rod. The top of the rubber boot should extend to here.

I added a ziplock tie and some gasket sealant as overkill, since I am installing a 26 year old part as a replacement!

Reassemble and test.

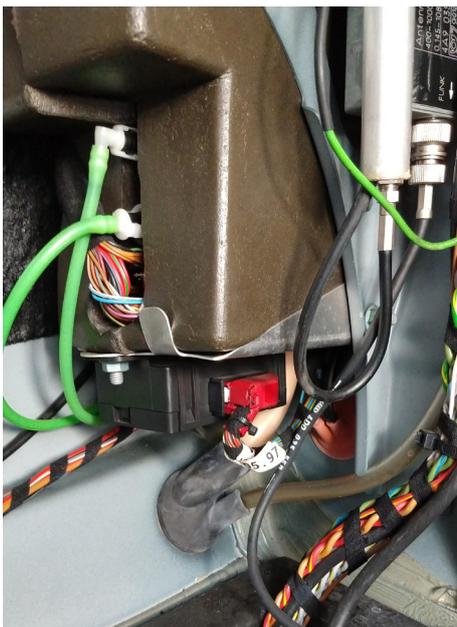
View of the central locking vacuum pump - located behind left boot compartment trim

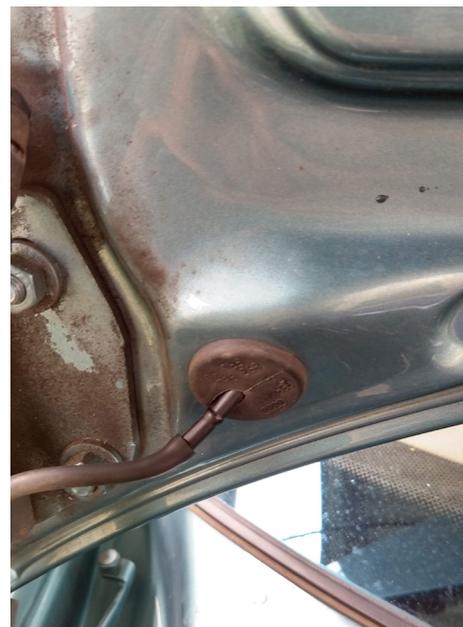
Pull this hose and block end whilst locking car with fob or key to prove you have a leaking actuator boot.
