C5 Audi Allroad (Wabco) Suspension Compressor Strip/Repair.

Here are some of my experiences stripping 2 off Audi Allroad C5 suspension compressors to see what makes them tick;

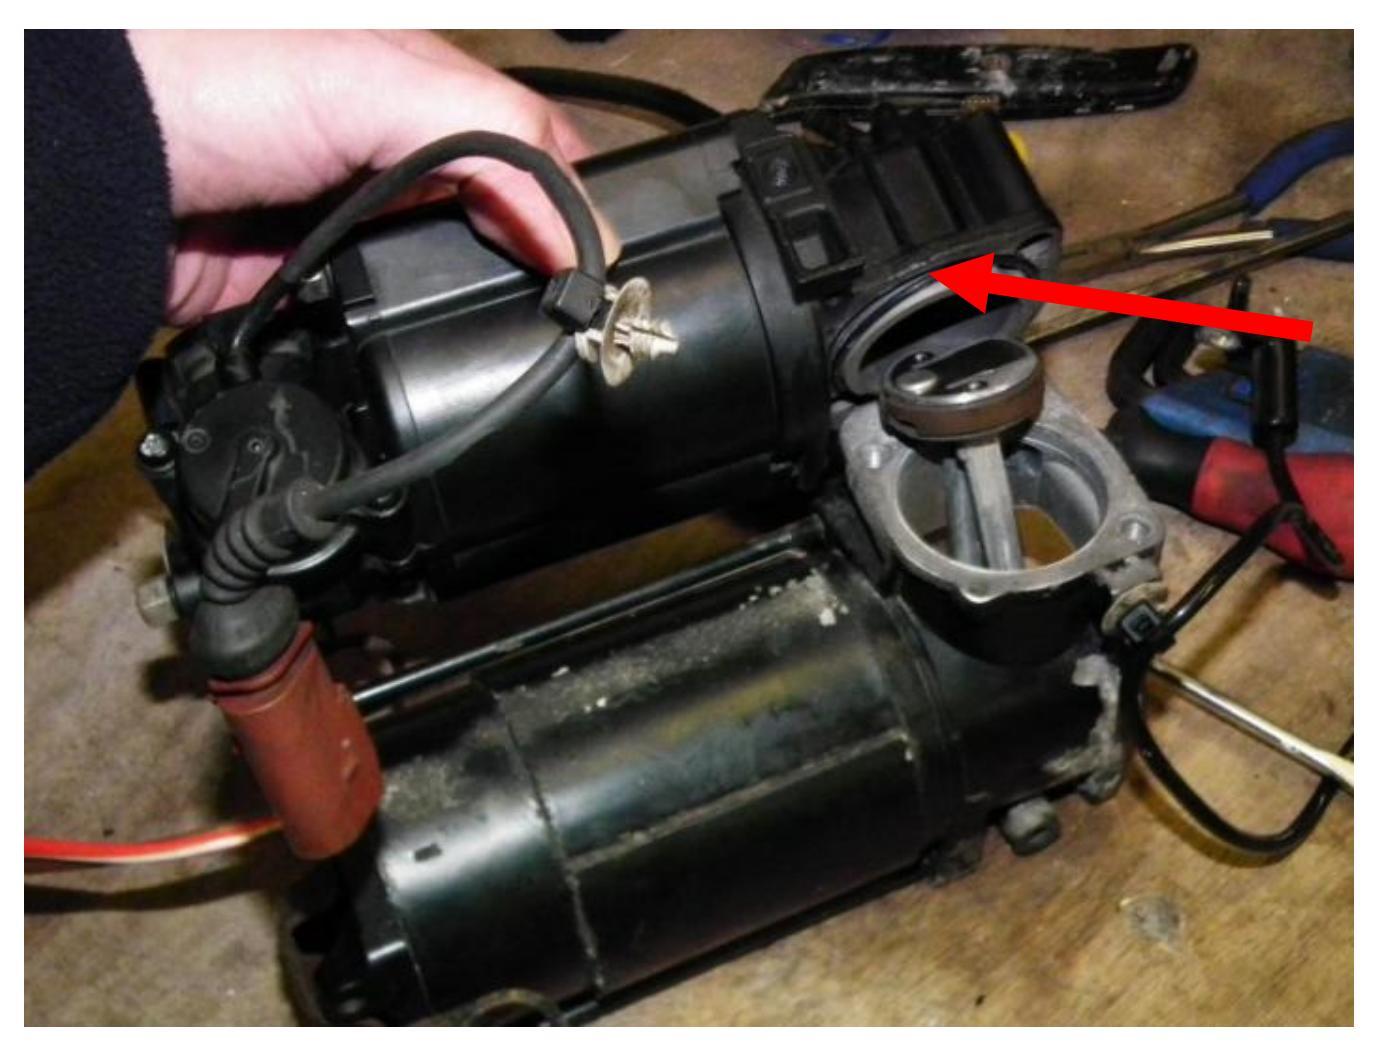
Photo below of the 1st stripped compressor dated 2004, showing the Compressor unit lifted off the Motor Assembly, red arrow showing the rubber o-ring.

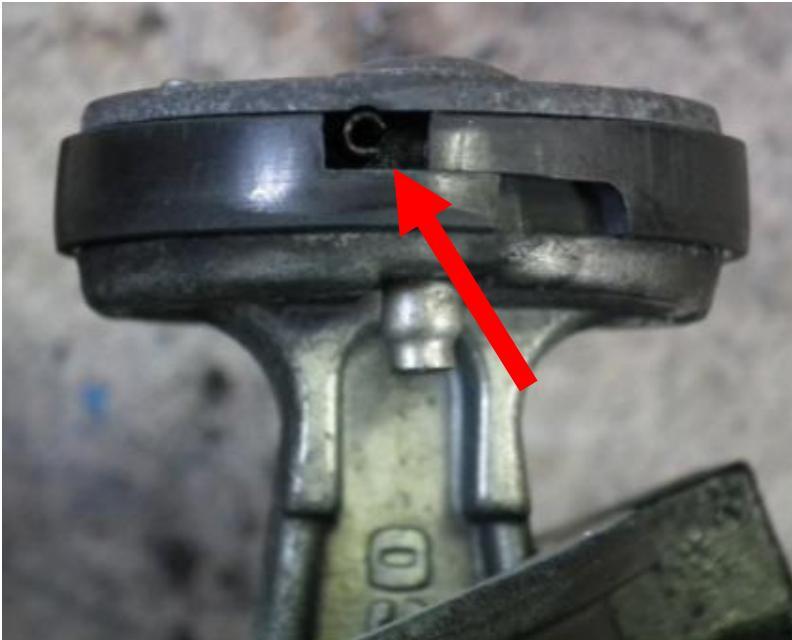
A Close up of piston and old PTFE ring fitted; The PTFE piston ring is tapered with most wear on the top half of the diameter almost seen in this photo. Careful if removing & refitting the Ring as there is a timing pin in the piston (see arrow opposite) which stops the ring rotating.

If removing the ring carefully note the way the ring fits on to the piston before removing, it has to be round the correct way to fit around this pin.

Basically the only moving parts are the rotating motor, crank and the piston, and a few one way valves. In the cases of both compressors I have replaced the PTFE Piston seal ring which both showed signs of being a loose fit in the cylinder and tapered wear on the outside diameter of the PTFE ring, both resulting in poor compression & noise.

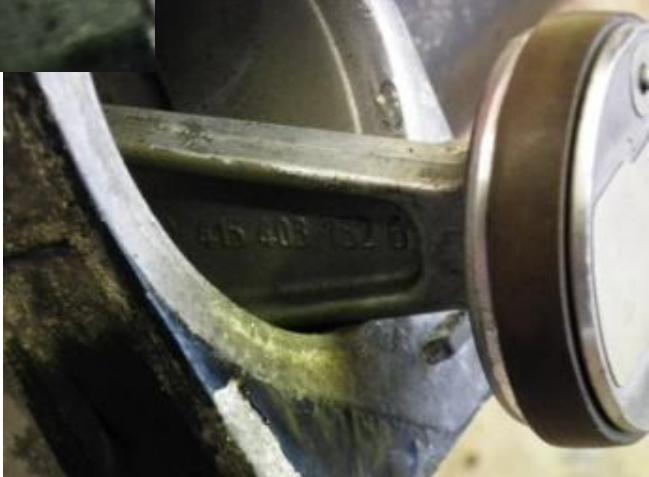
The photo opposite shows a part number "415 403 732 6" stamped on the conrod. I have had no joy ordering this part from WABCO, It doesn't seem to be on offer, feel free to try if any one has any contacts. (Not guaranteed to come with the ring though). Since looking at this I have found there is a kit part available for the piston ring on its own for other models.

Conrod part No 415 403 732 6 (Only if it comes included with the PTFE ring).

I have tried a few wabco parts places, in the UK, all responding to that piston assy part does not exist on there parts list, so no joy there ⁽³⁾ I have seen photos of a Wabco piston repair kit the only one I can buy is for the VW Touareg, VW part no 7L0 698 030 £108+VAT (new ring seal and bolts), but in my opinion it is too expensive to have a go to only find out it may be slightly different. Audi say the piston ring kit 7L0 698 030 available from VW is not on offer for our models. All I can say is it looks the same, it is the same wabco motor unit, but I have no other evidence or proof otherwise.

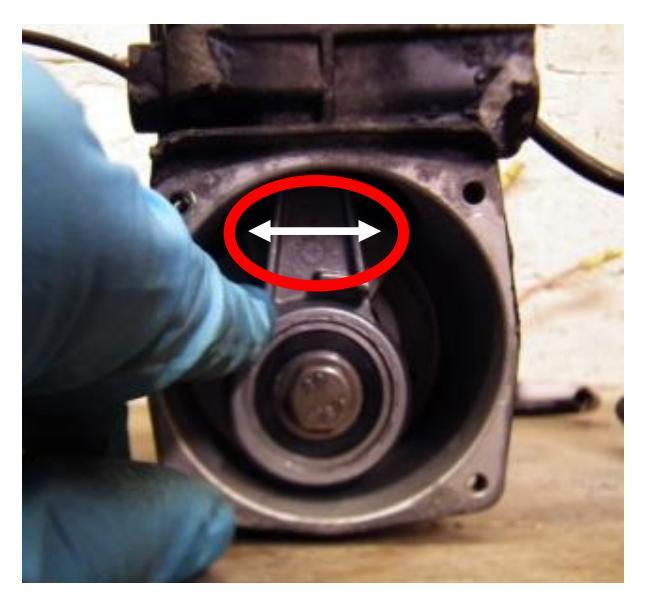
Removing the end plate (drill out 4 rivets) gives assess to the piston & crank. While the compressor is still assembled I could clearly move the piston side to side, too much free play is where the lack of compression & noise is coming

from.

See photo opposite showing an arrow in the direction of movement:

However the piston has no gudgeon pin and is fixed so it does need a little movement to allow it to move around in the cylinder bore when the crank is rotating around. The PTFE piston ring/seal is designed to take up this slack, to maintain the seal.

To replace the PTFE piston ring you do not need to remove this plate but I used the access here to test the new piston rings to make sure there was compression & not too much resistance in the bore when creating a prototype. The compressor unit part has no moving parts other than springs and one way valves, I even removed the silicon beads out the drier unit but there is no need to go in there it was all clean and looked to be in good condition, slight moisture around the inside of the casing but nothing too bad, Another area of failure could be the one way valves if they were to loose the spring or the rubber seals were to go but on both compressors these still looked and worked ok.

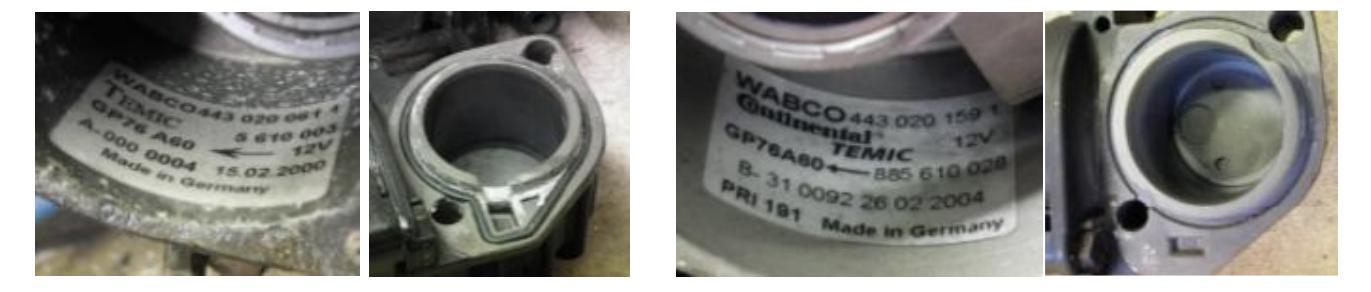
2 X Photos of My Original year 2000 Unit below

2 X Photos of year 2004 Unit below

Other findings: My original Allroad compressor is date stamped 2000 (2 photos above LH side) and it has slight differences to VinPetrol's one (dated 2004), the rubber seal between the motor housing and the compressor is not round on mine and follows a shape, also it was Allen bolts holding it together rather than torx on the newer version. I plan to include new rubber seals in a kit but due to this difference they may not be useful in some cases. Both seals however were fine and no issues with re-using them if needed, they do not add to the compression & are only to keep the elements out.

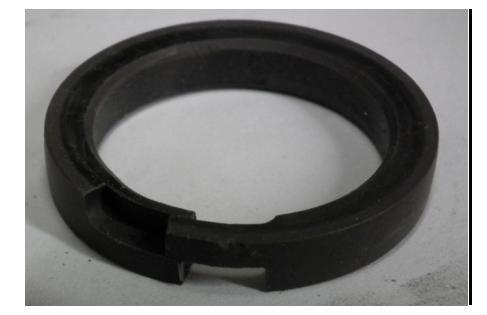
Piston ring as removed

I tried the stretching the ring, as the material is PTFE it is very soft and so easily I could pull it to open it out, will it stay out??... No, it closes very slowly deteriorating as you would expect through use,

Stretching it will lose its round shape but PTFE is very soft and will find its roundness once back in the bore and it has been running a few times, this is a reason PTFE is used as it will take up any un-evenness in the bore, not to mention its high range of working temp properties and its very low friction hence perfect in a dry unit.

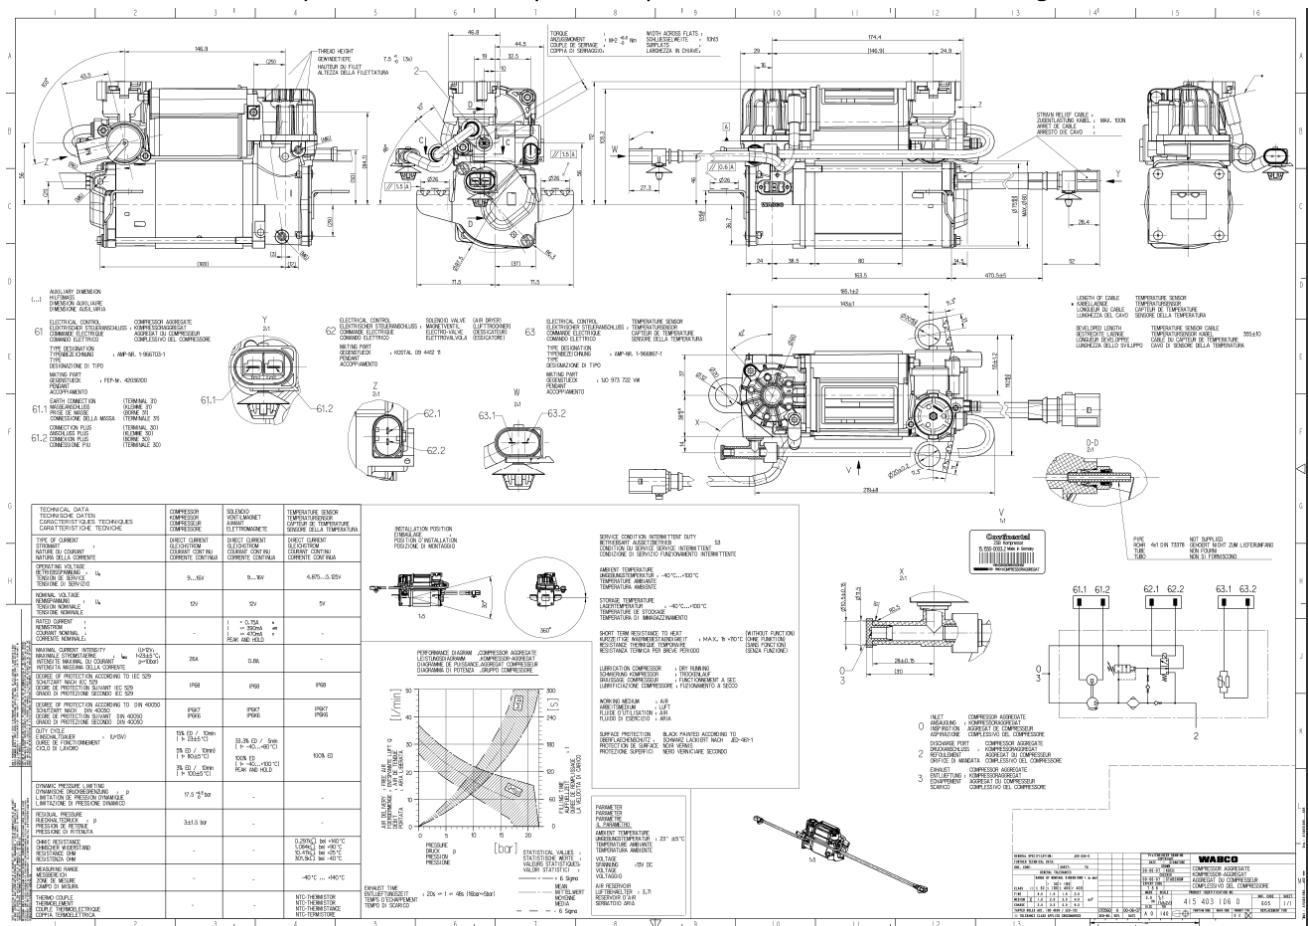
The Allroad compressors are Made by WABCO part number 415 403 106 0 drawing seen below:

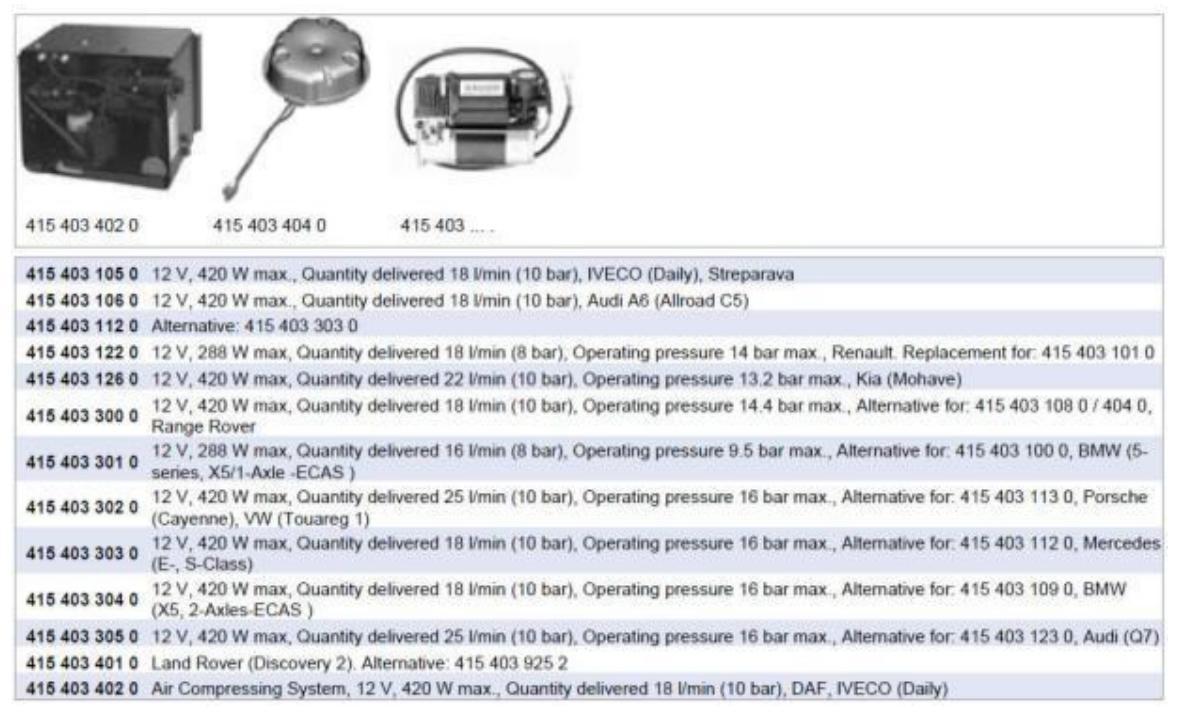
Similar style compressors can be found from the wabco parts list below: It seems to be the drier units, mounting brackets & electrical connections that seem to differ on some models. (Based on a visual comparison only)
