Repairing passenger airbag

Removing and installing passenger airbag unit on RHD vehicles 07.96 ä

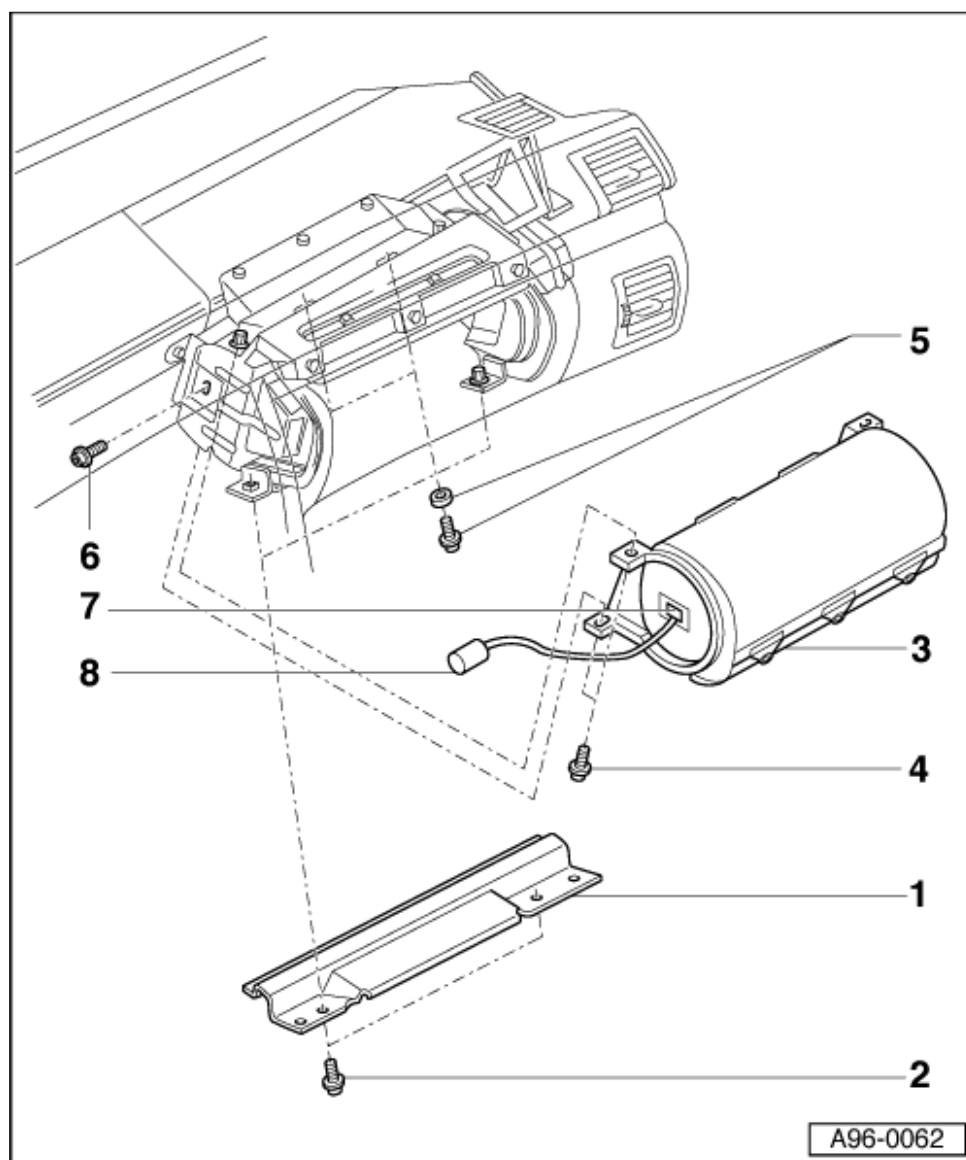
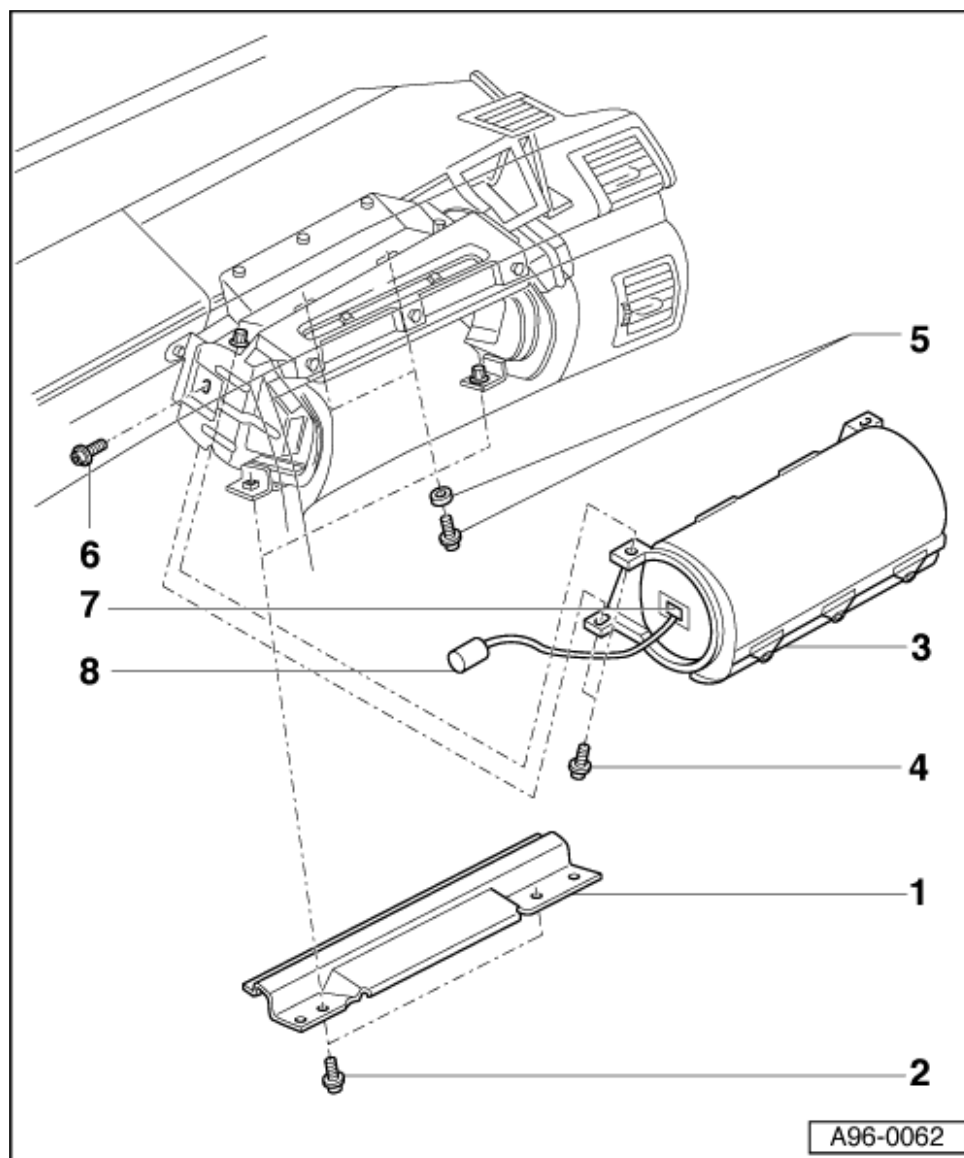
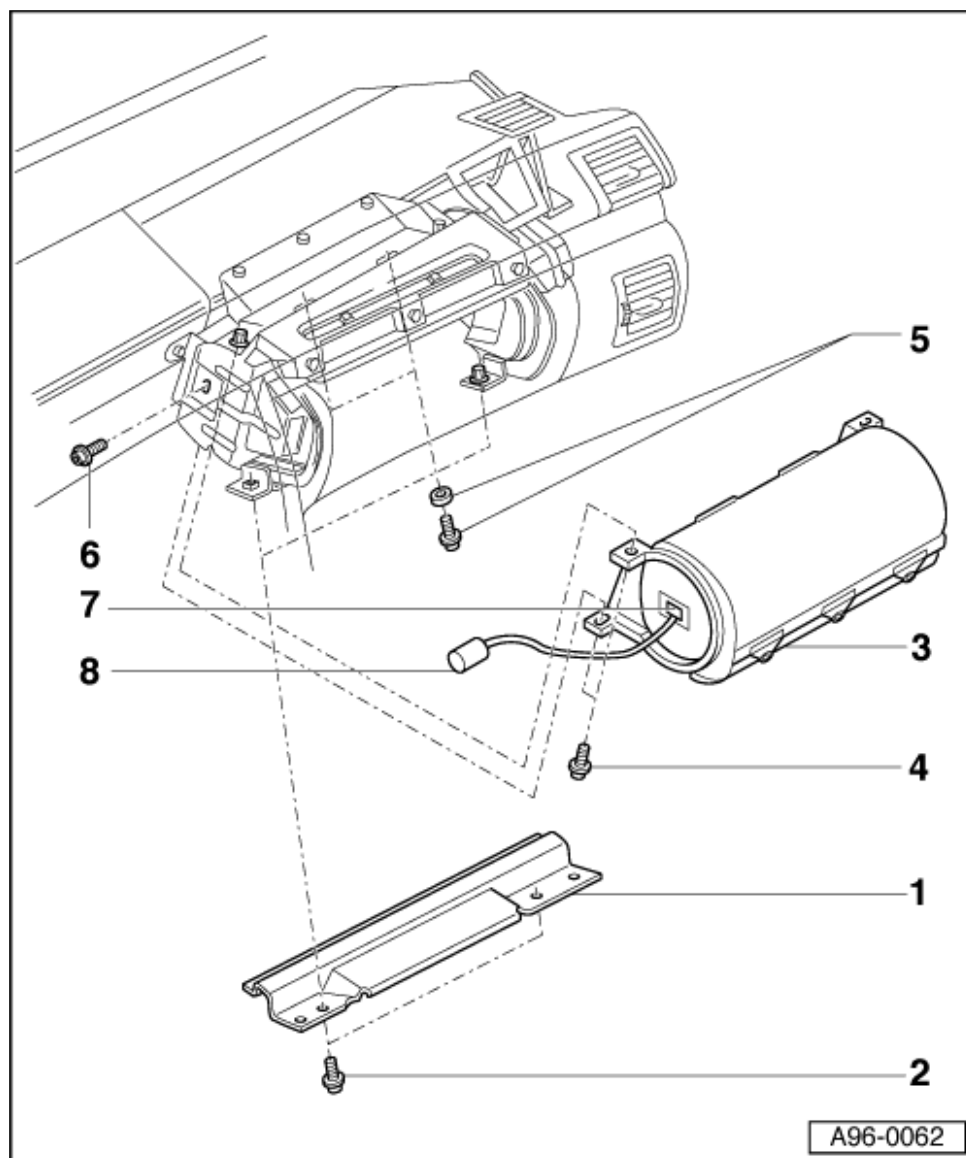
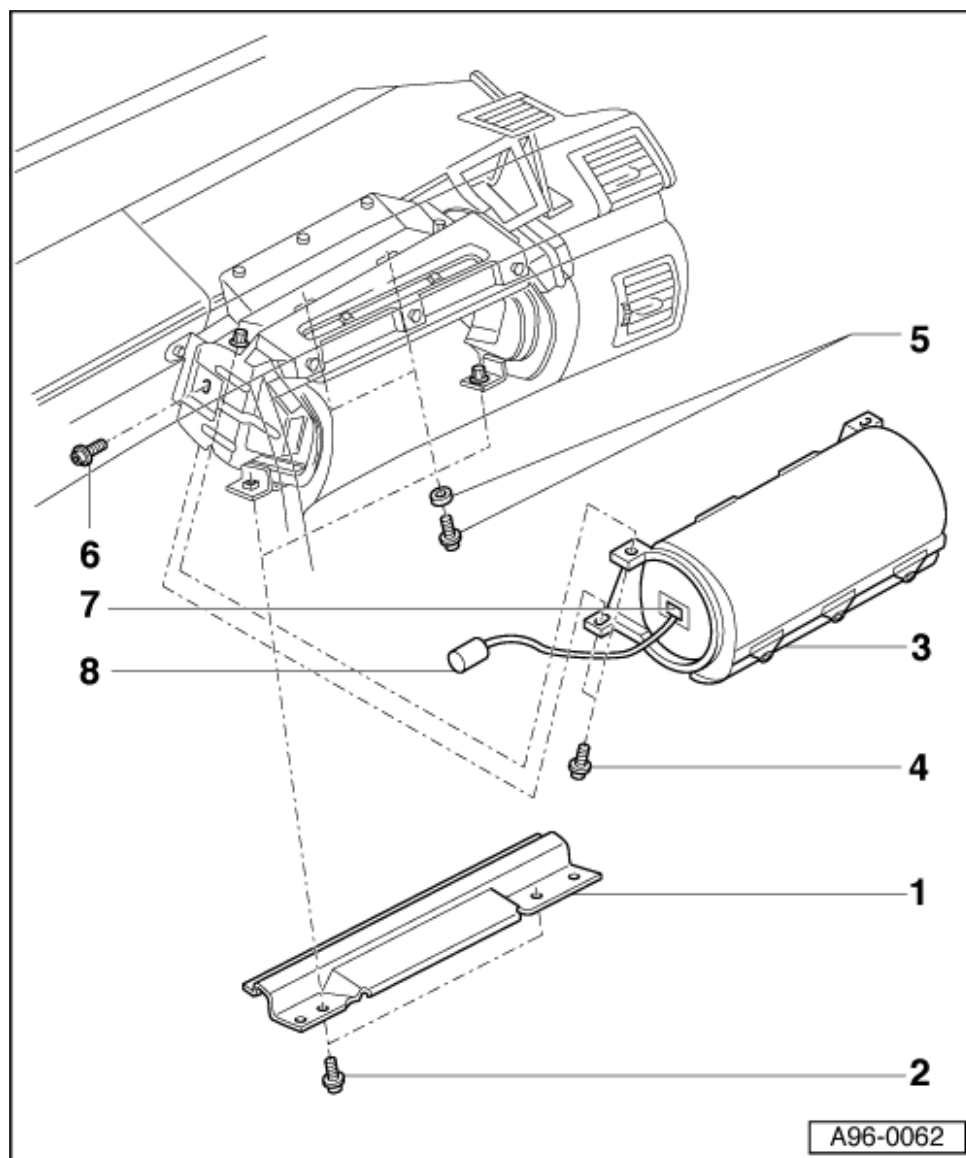
A96-0062

Exploded view in Fig. is a mirror image.

1. Airbag guide
2. Bolt - 5 Nm
◆ 2 off

3. Passenger's airbag unit

- Unscrew 4 bolts -Item 4- of airbag unit.
- Release and detach orange connector - Item 8-.
- Remove airbag unit downwards and lay down with cushioned side facing upwards.
- ◆ Install in reverse order, note the following:
 - Switch ignition on.
 - Connect

- 4. Bolt - 9 Nm**
 ◆ 4 off

- 5. Bolt with washer - 5 Nm**

- ◆ For retaining frame
- ◆ 2 off
- ◆ Replace retaining frame after triggering of passenger's airbag

- 6. Bolt - 9 Nm**

- ◆ For retaining frame
- ◆ 4 off
- ◆ Replace retaining frame after triggering of passenger's airbag

- 7. Red connector**

- ◆ Must not

be
disconnected
from airbag
unit -Item 3-

- ◆ If connector
has been
detached
airbag unit is
defective
and must be
replaced

8. Orange connector

- ◆ Installation
position: At
top in dash
panel
opening for
glove
compartment

- ◆ Removing:
 - In vehicles with encoded radio/radio-navigation system (RNS) Refer to code; if necessary, establish.
 - Detach battery earthing strap/cable, cover over negative terminal.

- Open glove compartment.
- Unscrew glove compartment frame.
- Pull glove compartment frame backwards out of guides.
- Detach connector for glove compartment light; leave Bowden cable of lock connected.
- Lay aside glove compartment in passenger's footwell.

Important
There must be no-one in the vehicle when the battery is being connected.

- ◆ If the fault warning
light (K 75) for
airbag signals a
fault after assembly
the fault memory
must be erased and
again be
interrogated by
using fault reader
V.A.G 1551.
